# Good, Bad and Ugly

Photos and captions by AVCM(AW) Dave Kennon, Naval Safety Center

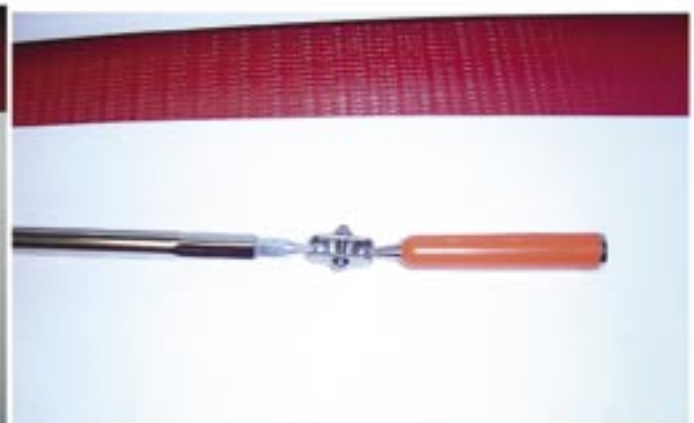
**Bad:** The NAMP (Volume 5, Chapter 13, paragraph 13.4.2.d) outlines the requirements for multi-piece tools. This magnet shows a good example of improper peening. In this case, the bolt was too long for the “peening” to be effective (only the last couple of threads and bolt had been bent). The nut backed off, resulting in a three-piece tool. The best solution is either to spot-weld or cut and grind the bolt to length before peening.

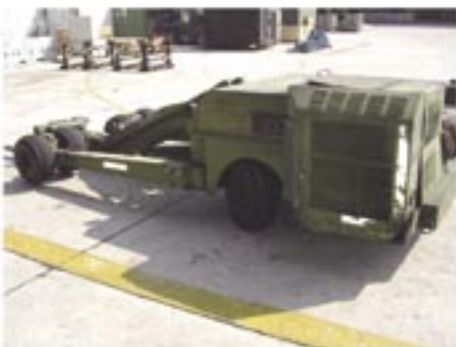
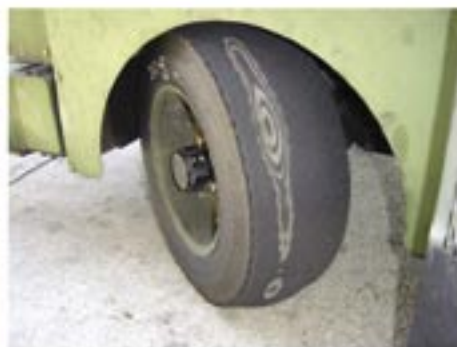
**Ugly:** What's wrong with this picture? This weapons loader apparently is ready to go; however, a closer look shows the tread on the 12-ply tire has worn through four layers. How far can you go before the tire blows? Not too far, and I hope not while loading or carrying ordnance!
